## Water Compliance Inspection Report

# **NPDES Inspection Report**

**Permit # IDR05I314**

**Young Living Farm**

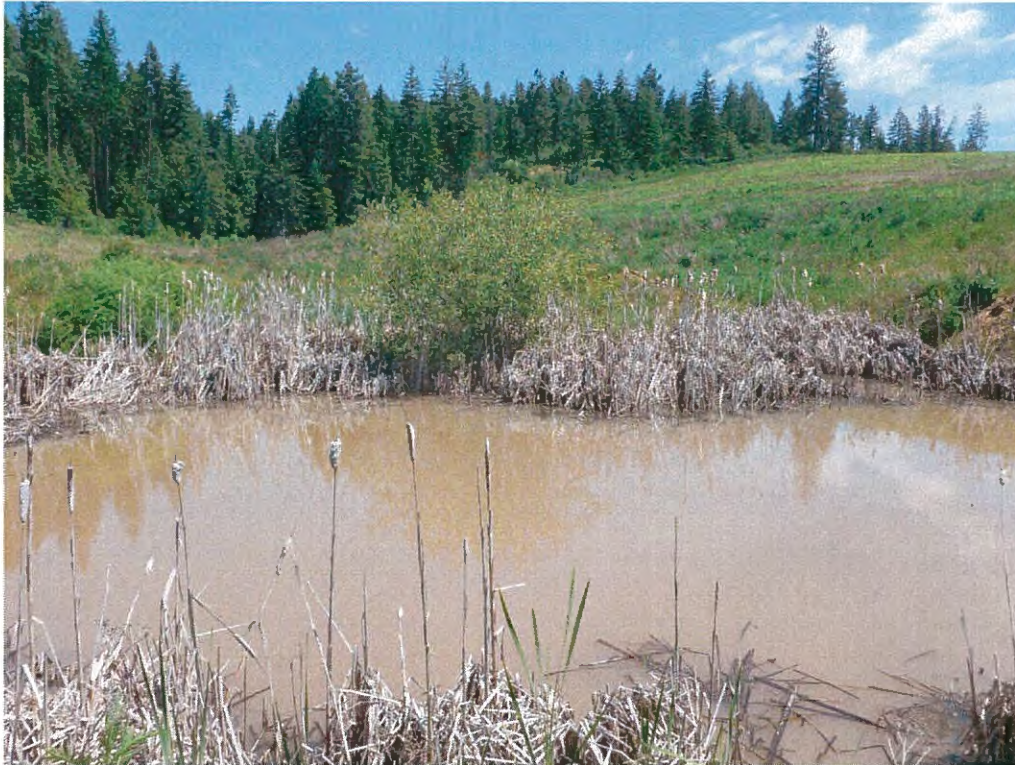
Mr. Sagers took me on a tour of the facility. Site maps appear in **Attachment A** and a photograph log appears in **Attachment B**. I followed the path of flow from the north end of the facility to an unnamed pond (**Photo 1**), where Mr. Sagers said the facility has been working with the U.S. Army Corps of Engineers on plans to build a reservoir. Downstream of the unnamed pond, I inspected Pond 1a (**Photo 2**), Pond 2 and Pond 3 (**Photo 3**).

**Photo 1 / P1050166** – Northerly view of pond located upstream of Pond 1a

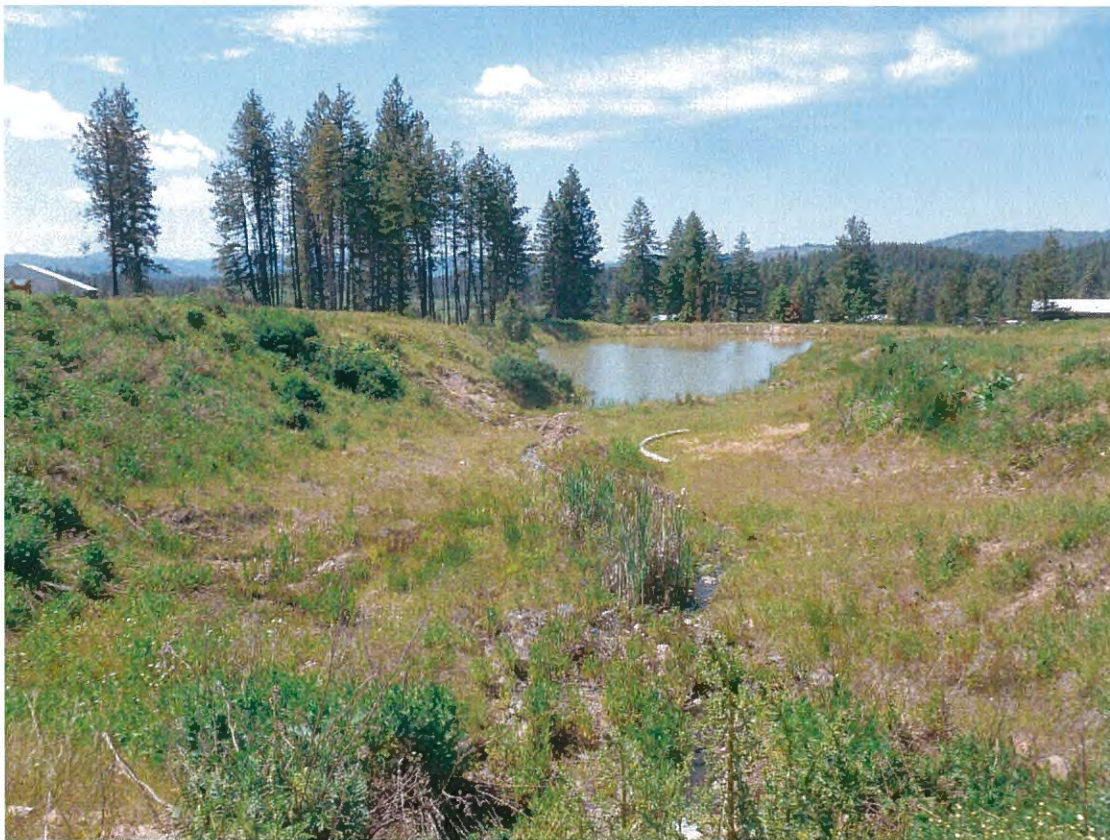
**Photo 2 / P1050165** – Southwesterly view of Pond 1a

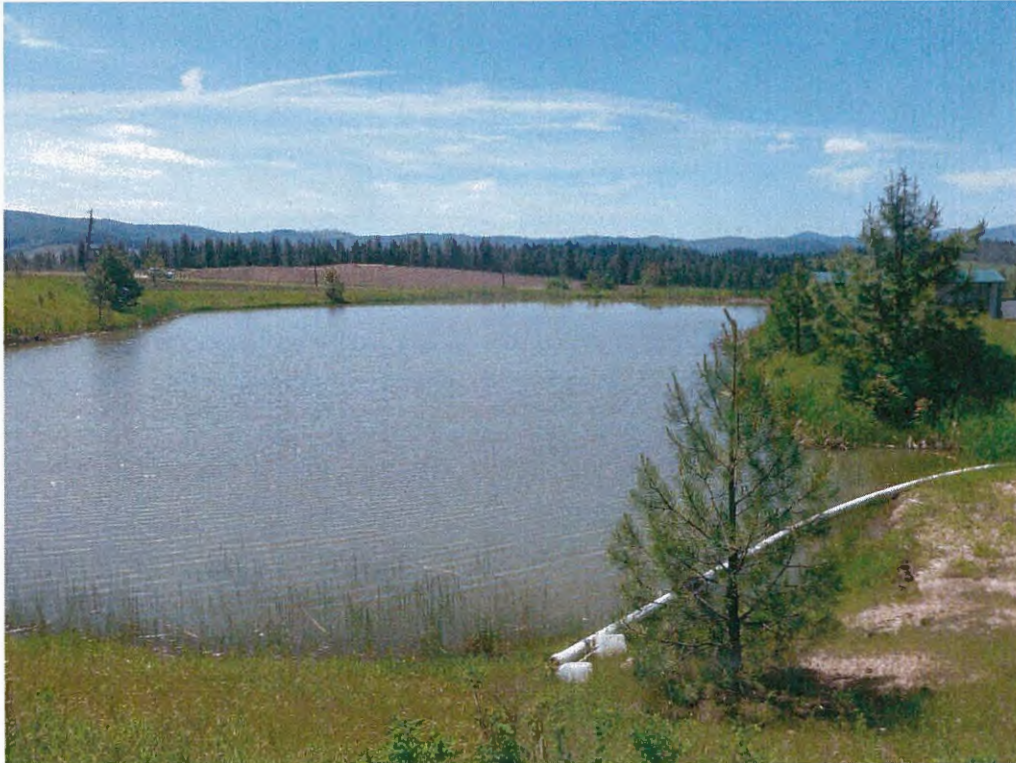
**Photo 3 / P1050156** – Southerly view of Pond 3

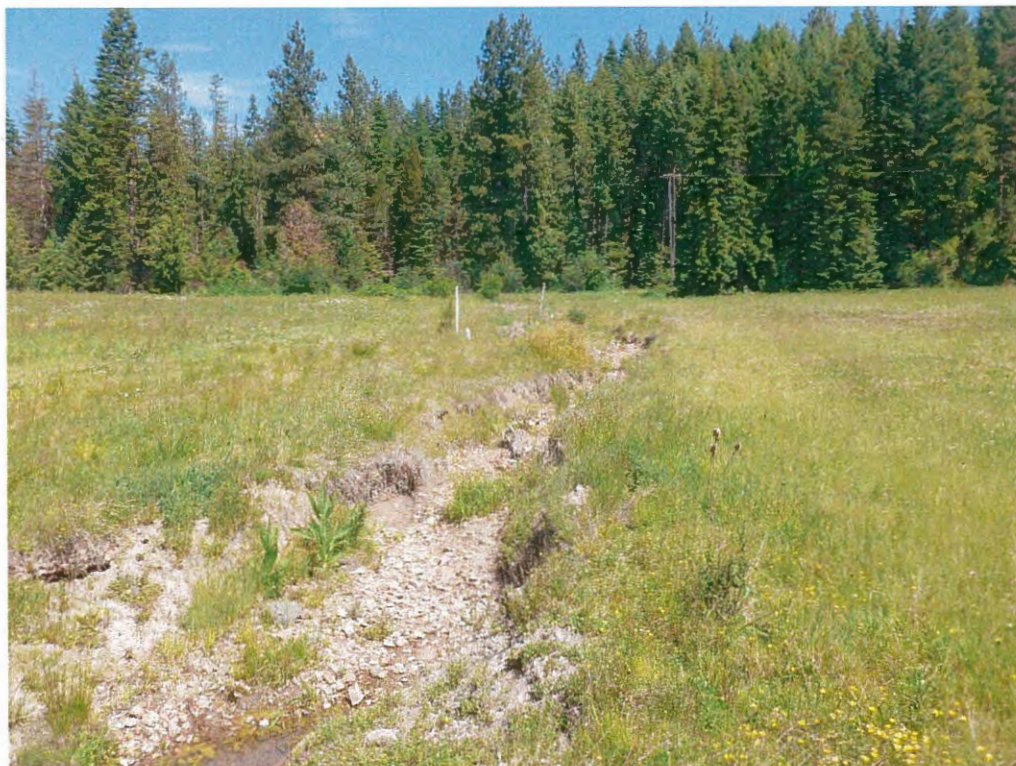
In the northwest portion of the property, I observed a stream bed (**Photos 4 & 5**) in a wetland area. Mr. Sagers said that the facility does not farm within 70 feet of the stream bed. The streambed and the ponds were located upstream of Pond 4 (**Photo 6**), which discharges through an outlet pipe (**Photo 7**) to a stream bank (**Photo 8**) that the facility has identified as Outfall 002. I observed flow in the stream, which continues to North Fork Coon Creek, but I did not observe a discharge from the outlet pipe of Pond 4 at the time of the inspection. Mr. Sagers said that Pond 4 is used for irrigation and cooling during distillation. The cooling water flows from Pond 4 through the distillery to Pond 1a. Mr. Sagers said that Pond 4 is typically drawn down in the summer and refills to the point of discharge around January or February.

**Photo 4 / P1050148** – Northerly view of the stream bed in the northwest portion of the facility

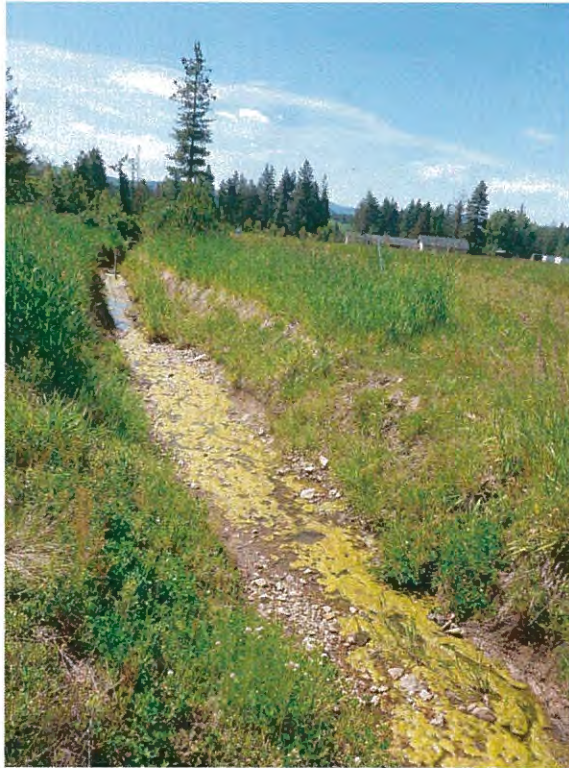
**Photo 5 / P1050149** – Southerly view of the stream bed in the northwest portion of the facility

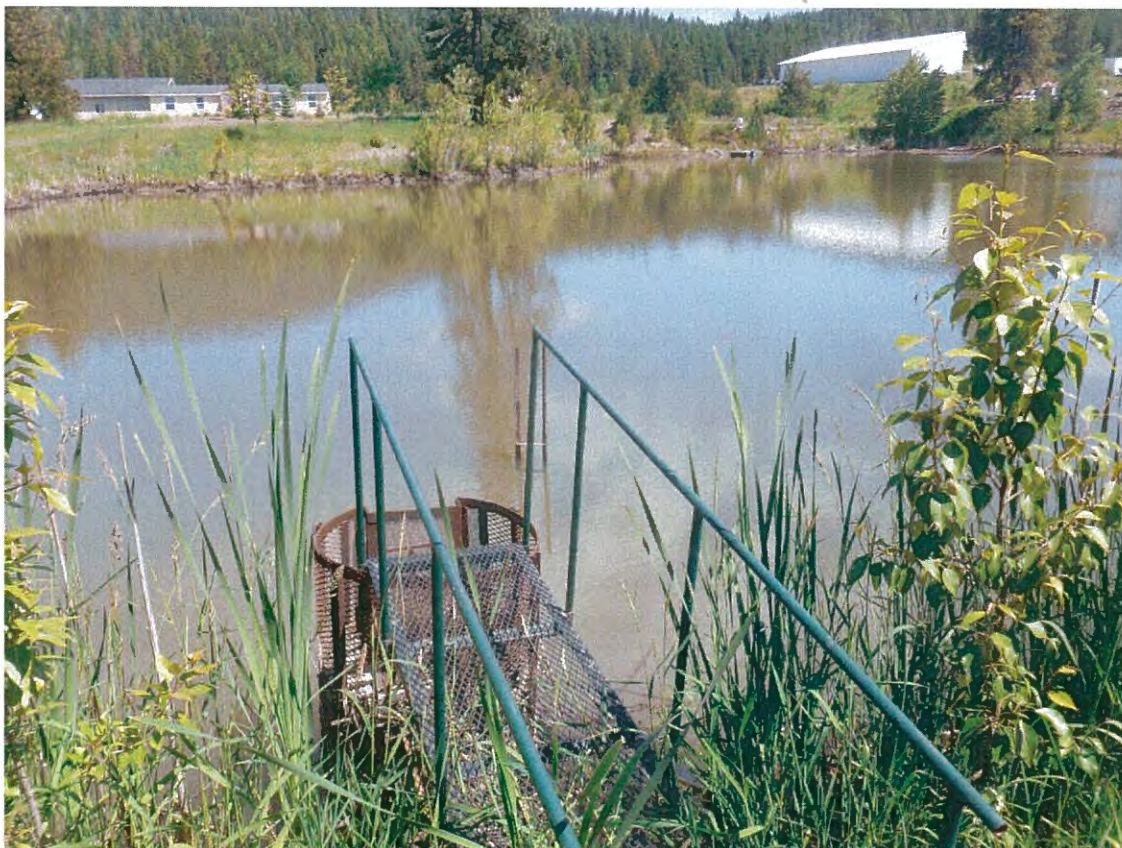
**Photo 6 / P1050159** – Northerly view of the outlet of Pond 4

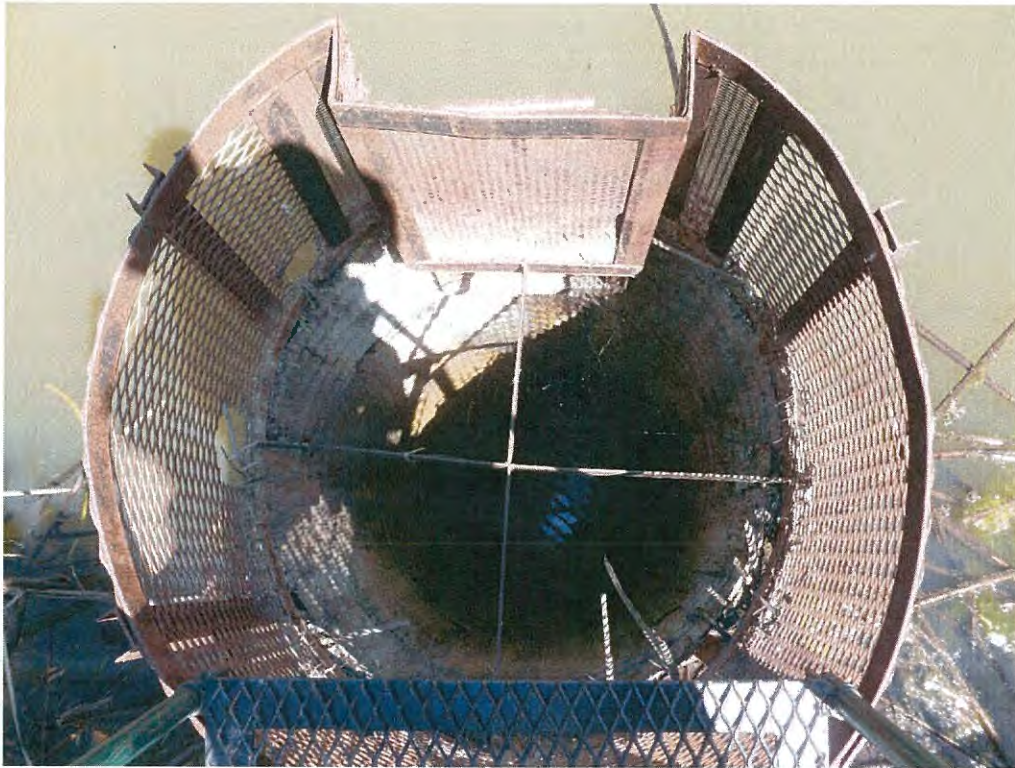
**Photo 7 / P1050158** – Detail view of the outlet of Pond 4

During the inspection, Mr. Sagers identified a point on the bank of a stream (**Photo 8**) as the sampling location for Outfall 002. To ensure that samples are representative of the industrial stormwater discharge from the facility, I reminded Mr. Sagers to sample at a point before the discharge commingles with non-industrial downstream flows. If necessary, I pointed out that the facility could consider an alternate sampling point such as the outlet pipe of Pond 4 (**Photo 7**).

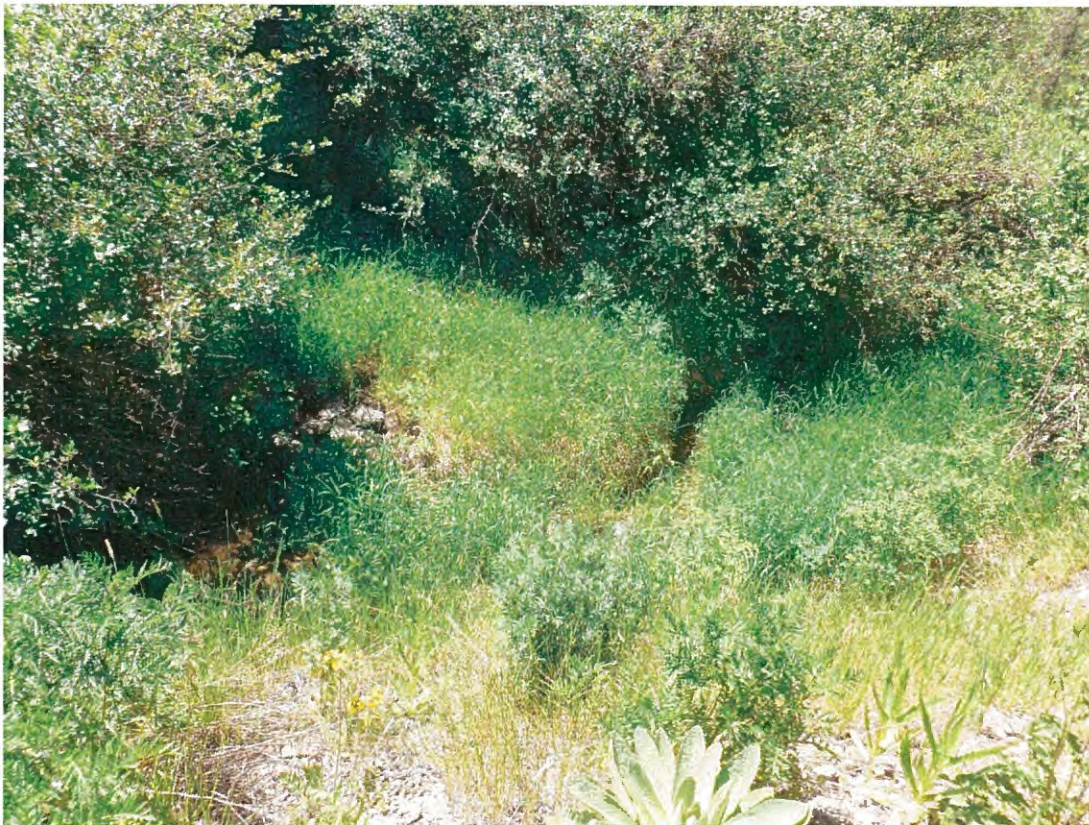
**Photo 8 / P1050160** – Southerly view of the stream that receives flow from Pond 4 (Outfall 002)

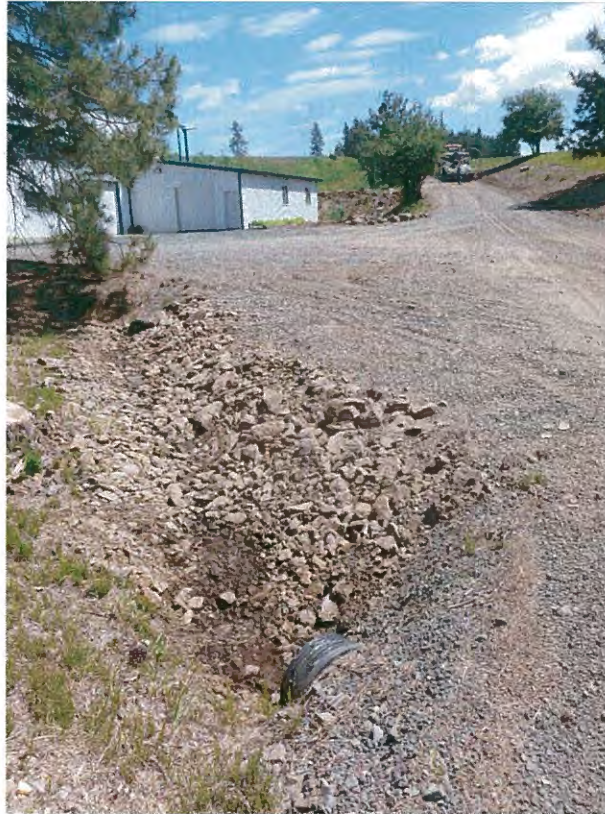
On the south side of the distillery building, I observed a drainage channel (**Photo 9**) upstream of Outfall 001 (**Photo 10**), which was upstream of another drainage channel (**Photo 11**) that directs flow to North Fork Coon Creek.

**Photo 9 / P1050169** – Easterly view of drainage channel upstream of Outfall 001

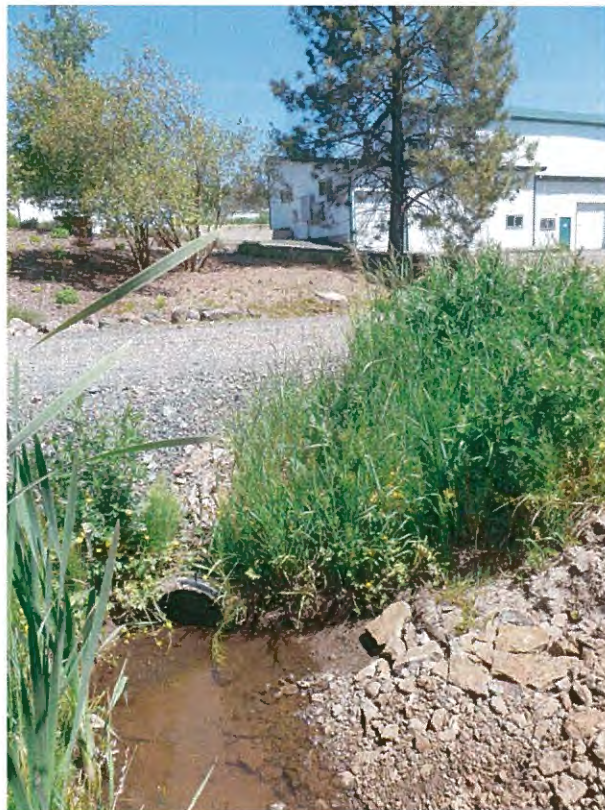
**Photo 10 / P1050167** – Outfall 001

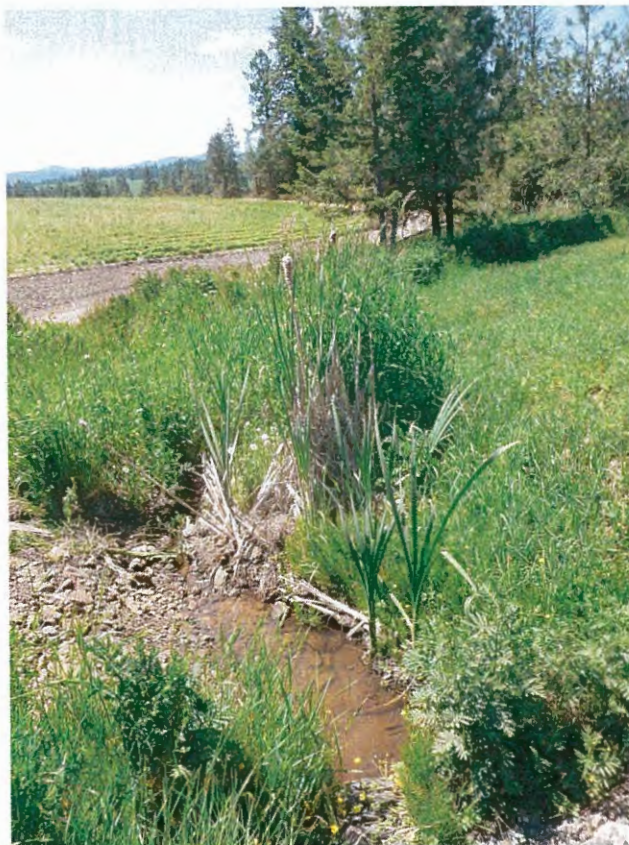
**Photo 11 / P1050168** – Southerly view of drainage channel downstream of Outfall 001

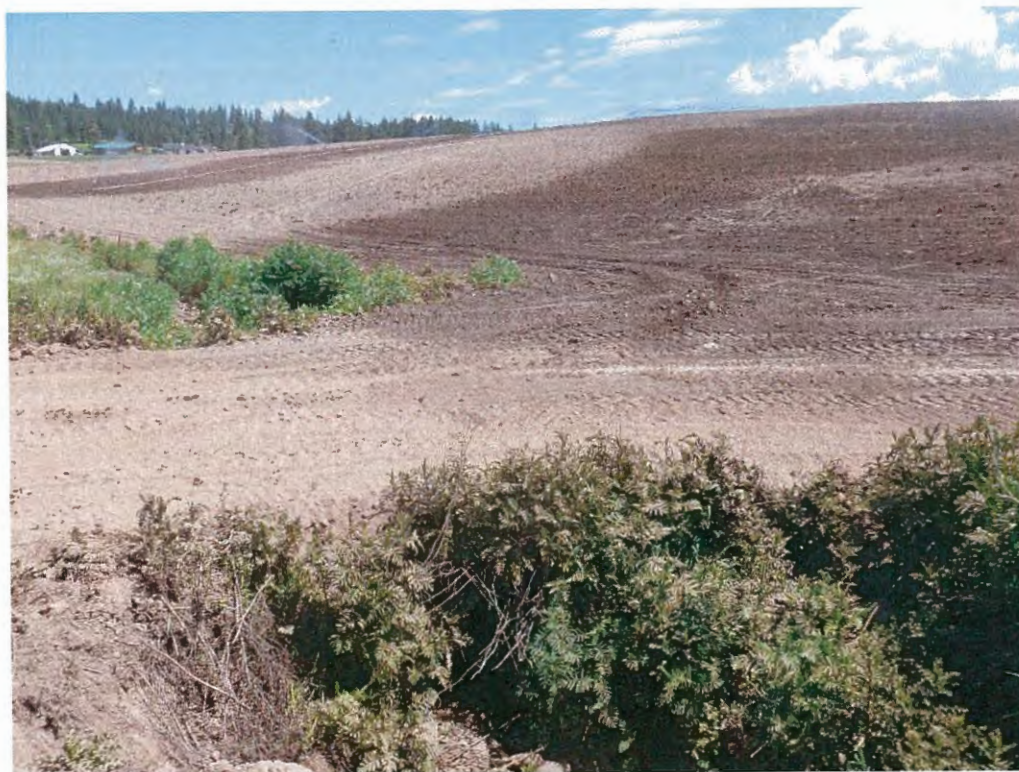
In the southwestern portion of the facility, I observed cleared fields (**Photo 12**), a scrap metal accumulation area (**Photo 13**) and a soil stockpile area (**Photo 14**).

**Photo 12 / P1050171** – Northeasterly view of the southern portion of the facility

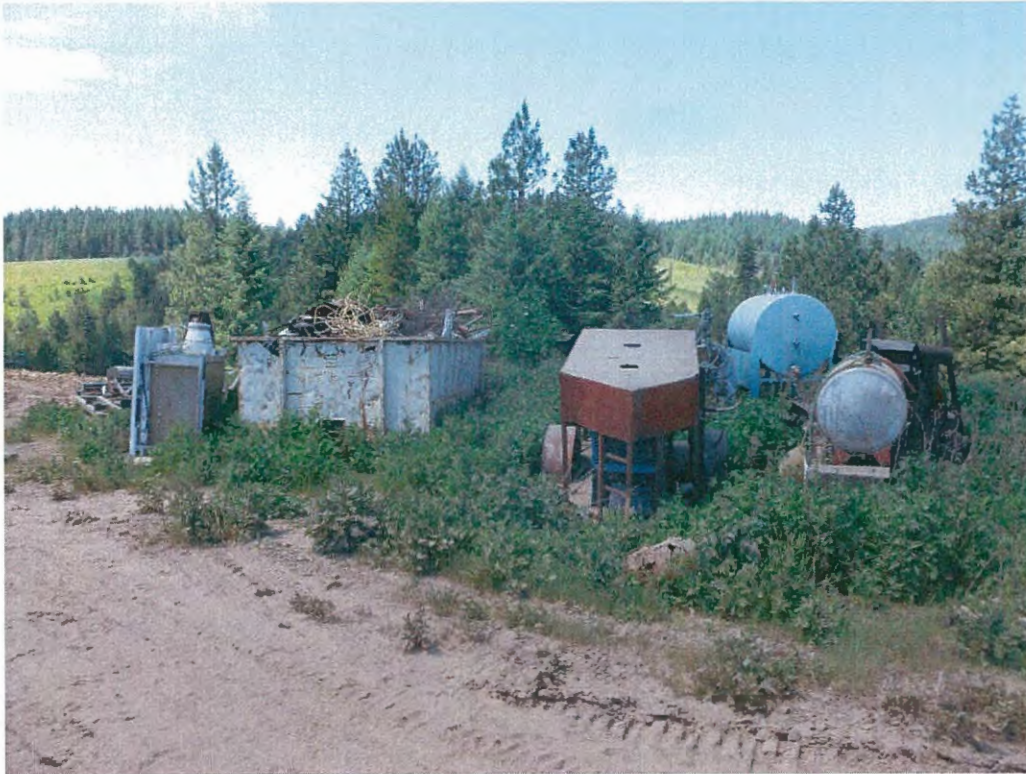
During the inspection, I observed a dumpster (**Photo 13**) without a lid or other means to control potential leaks. The dumpster was located in a scrap metal accumulation area in the southwestern portion of the facility.

**Photo 13 / P1050175** – Westerly view of the scrap metal accumulation area near the southwestern border of the facility

Part 2.1.2.2 of the MSGP states: “Keep all dumpster lids closed when not in use. For dumpsters and roll off boxes that do not have lids and could leak, ensure that discharges have a control (e.g., secondary containment, treatment).”

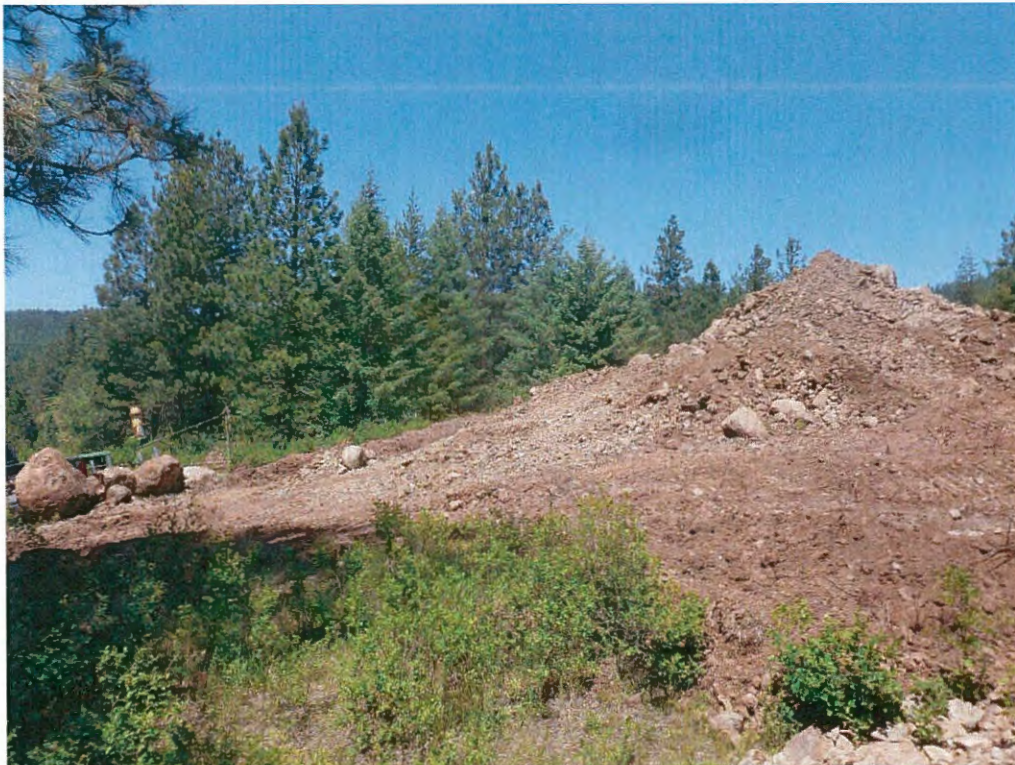
In the southwestern portion of the facility, I observed a soil stockpile (**Photo 14**) located on the edge of slope without stabilization or control measures to minimize the discharge of sediment from the site.

**Photo 14 / P1050178** – Northerly view of the soil stockpile area near the southwestern border of the facility

Part 2.1.2.5 of the MSGP states that “you must minimize erosion by stabilizing exposed soils at your facility in order to minimize pollutant discharges... You must also use structural and non-structural control measures to minimize the discharge of sediment.”

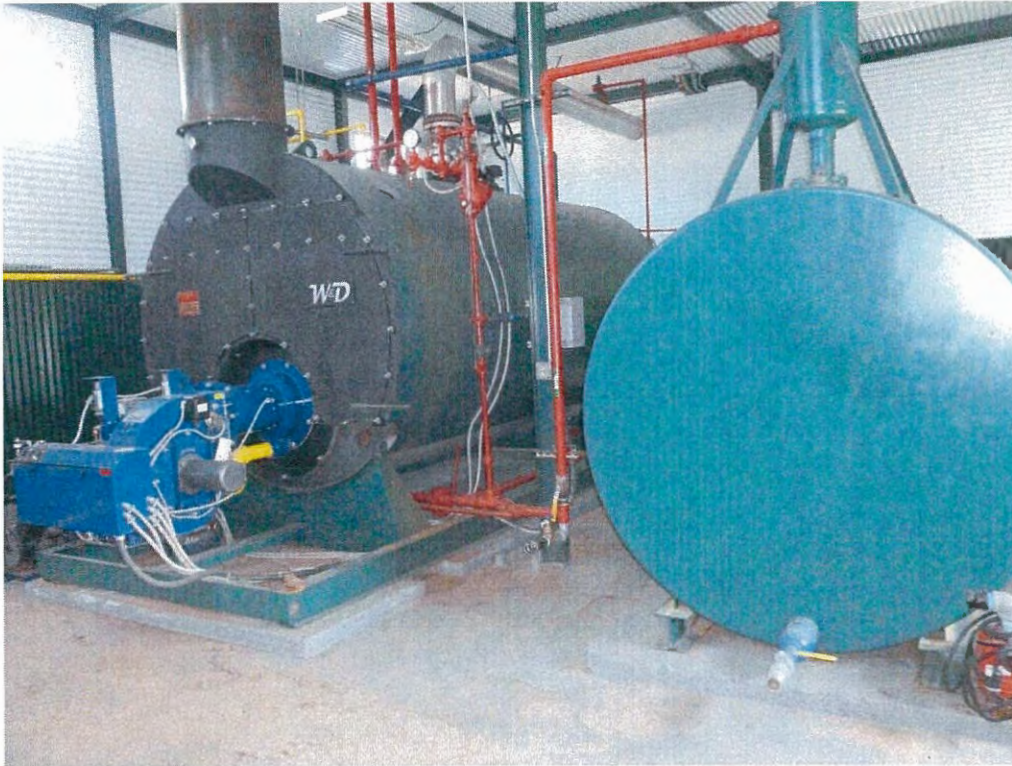
In the distillery building, I inspected the boiler and blowdown water collection tank (**Photo 15**). Mr. Sagers said that the blowdown water and floral water, which is used in the cooking process, are applied to the facility's roads for dust control. Floral water and reflux water, which comes from the bottom of the cooker, are collected in tanks (**Photo 16**) located in the basement of the distillery. Reflux water is applied to compost piles (**Photo 17**) located northwest of Pond 3. Mr. Sagers said the facility has obtained a permit for wastewater reuse from the Idaho Department of Environmental Quality (IDEQ). He said that the facility also applies a fish emulsion fertilizer, and that the facility does not use pesticides or herbicides.

**Photo 15 / P1050182** – Boiler (left) and boiler blowdown water collection tank (right)

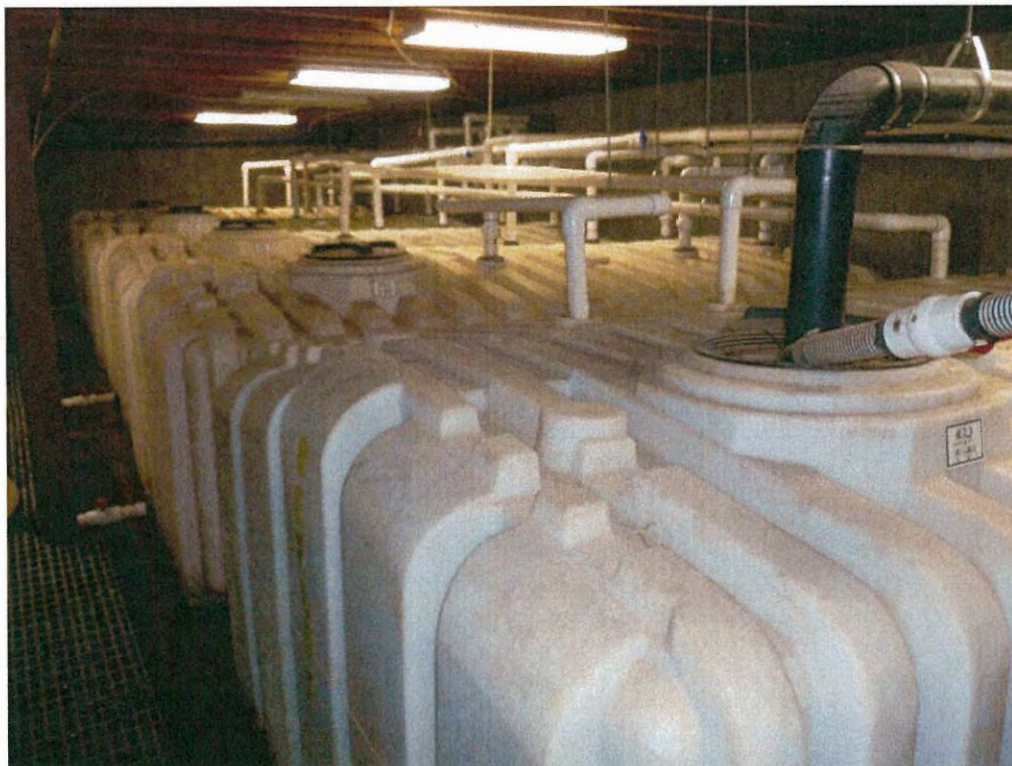
**Photo 16 / P1050187** – Wastewater tanks in the basement of the distillery

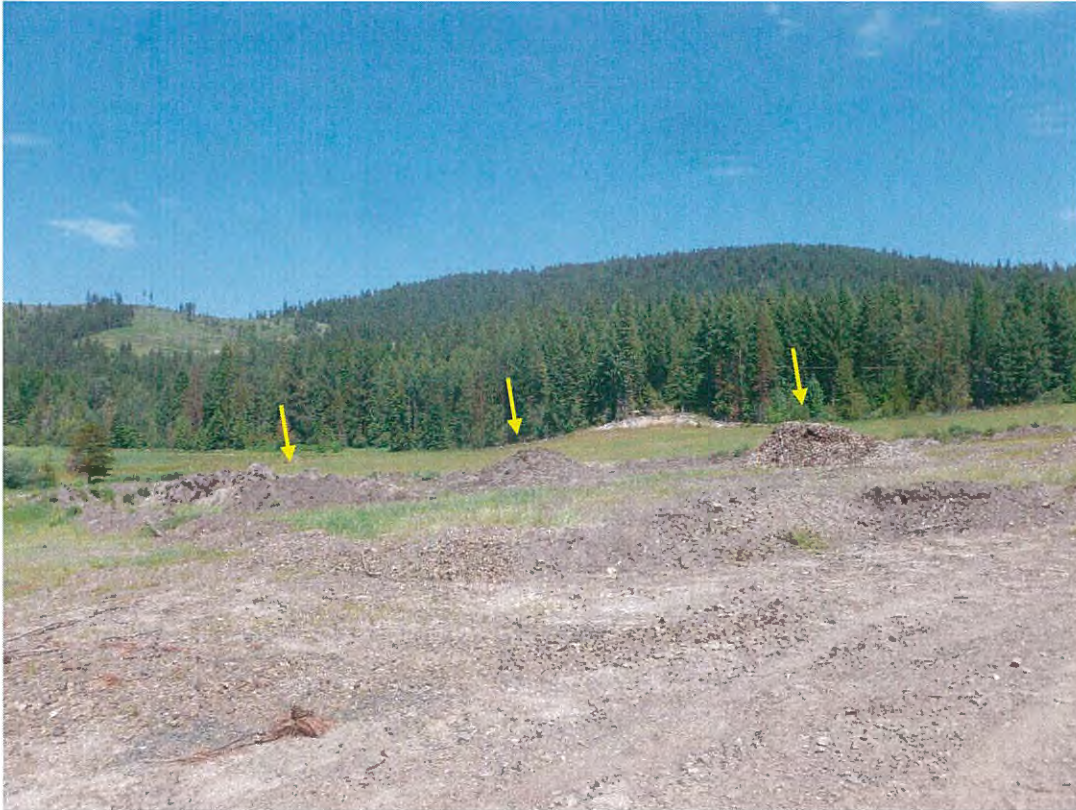
**Photo 17 / P1050162** – Northerly view of compost piles (arrows) located northwest of Pond 3
